TEST REPORT

No.: E190729004-01

No.	Test Item	Test Basis	Test Conclusion
1	IP6X	Refer to EN 60529-1991/A1:2000	Pass

Sample No.	Sample name	Model	Quantity
E19072900401	M5 Molding Line Series (male and female) +M5 Panel Series (male and female)	050004-03-002 050004-04-002 050004-05-001 050004-06-001	1 pc
E19072900402	M5 Welding Wire Forming Series (male and female)	050004-20-001 050004-21-001	1 pc
E19072900403	M9 Panel Type Series (male)	090005-03-001	1 pc
E19072900404	M9 Welding Wire Forming Series (male and female)	090005-20-001 090005-21-001	1 pc
E19072900405	M9 molding Line Series (male and female)	090005-05-001 090005-06-001	1 pc
E19072900406	M9 Panel Series (female)	090005-04-001	1 pc
E19072900407	M8 Distribution Box Series	920105-06-001	1 pc
E19072900408	M9 Series assembly type	090005-01-001 090005-02-001	1 pc
E19072900409	M12 Distribution Box Series	920105-08-023	1 pc

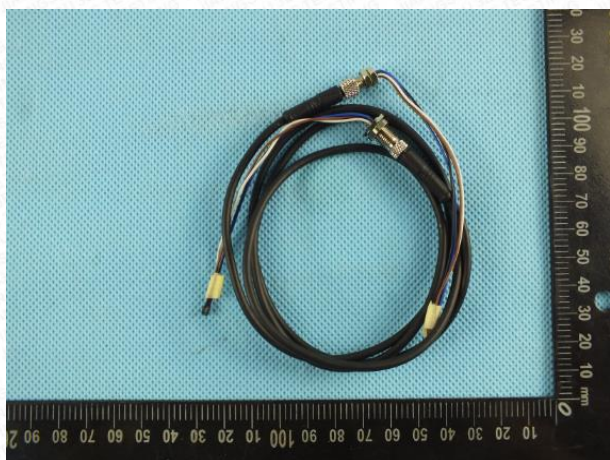
Fig.1 Sample photo before the test(1#)

Before the test, the appearance of the sample is normal

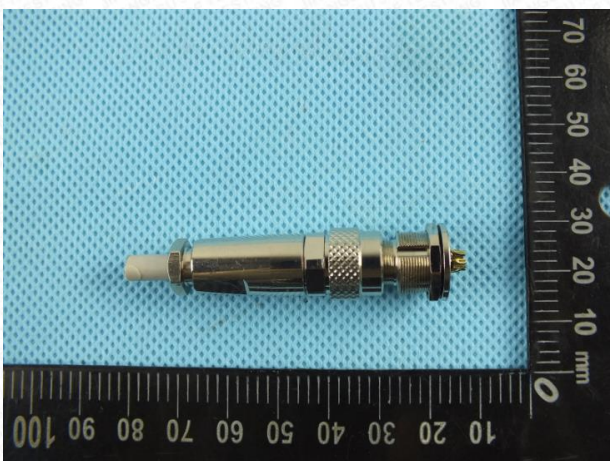
Fig.3 Sample photo before the test(3#)

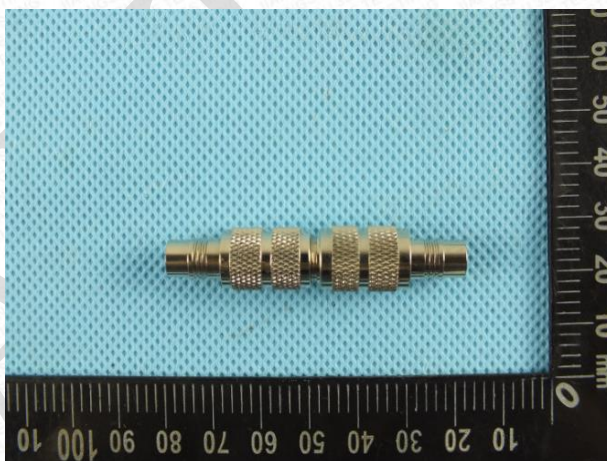
Fig.4 Sample photo before the test(4#)

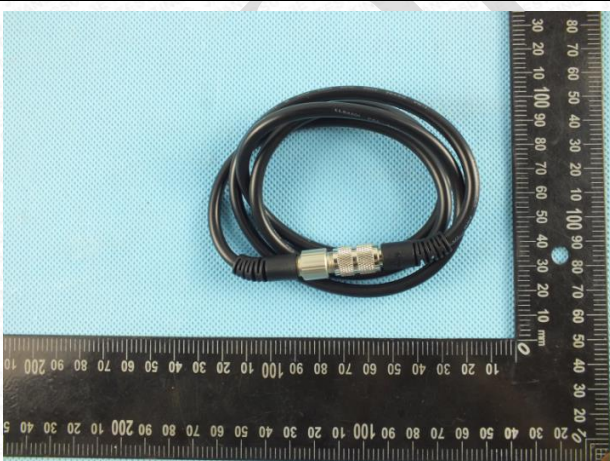
Fig.5 Sample photo before the test(5#)

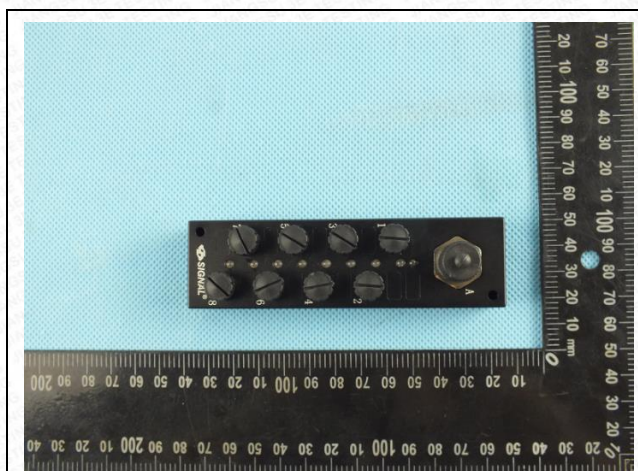
Fig.7 Sample photo before the test(7#)

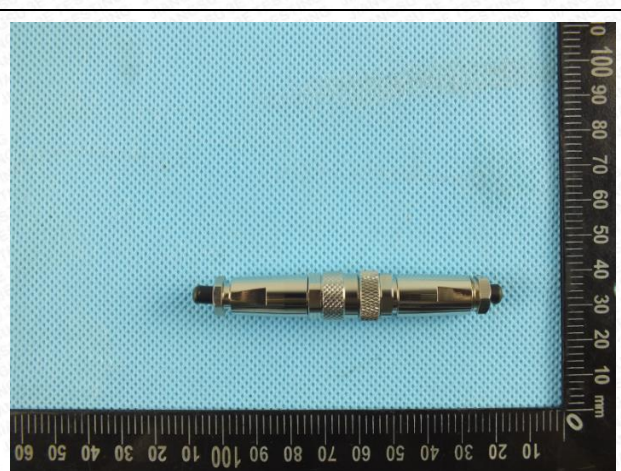
Fig.8 Sample photo before the test(8#)

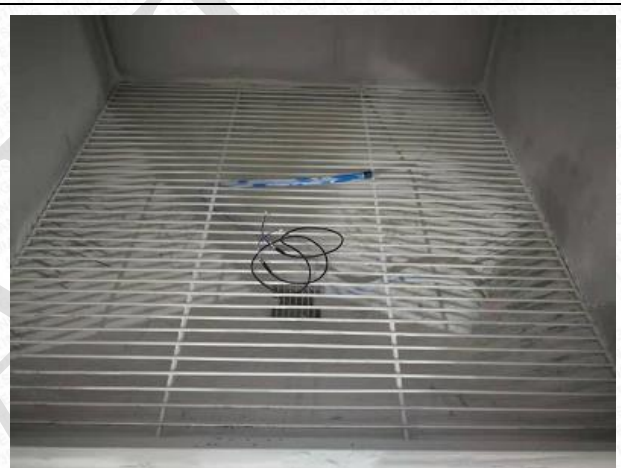
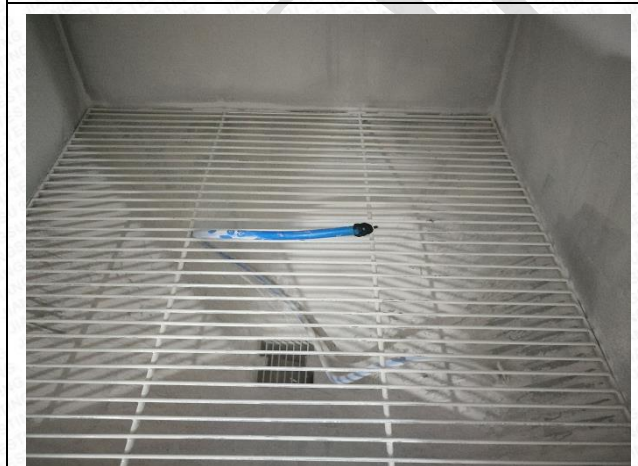
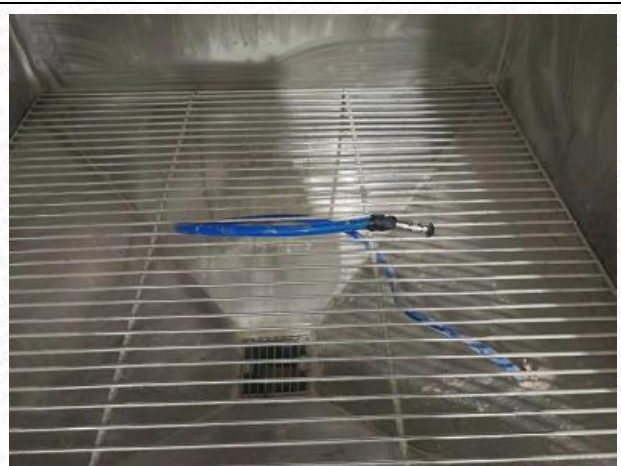
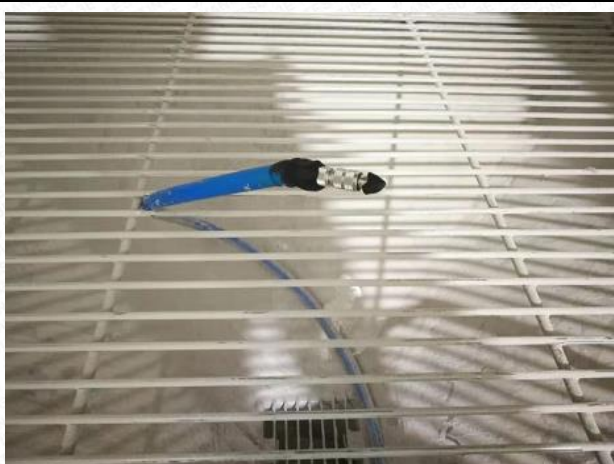
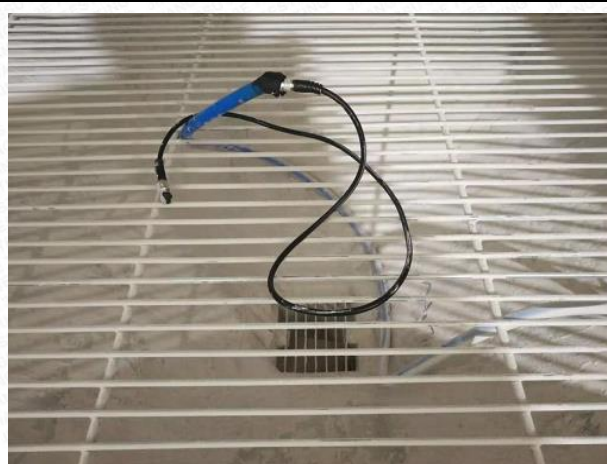
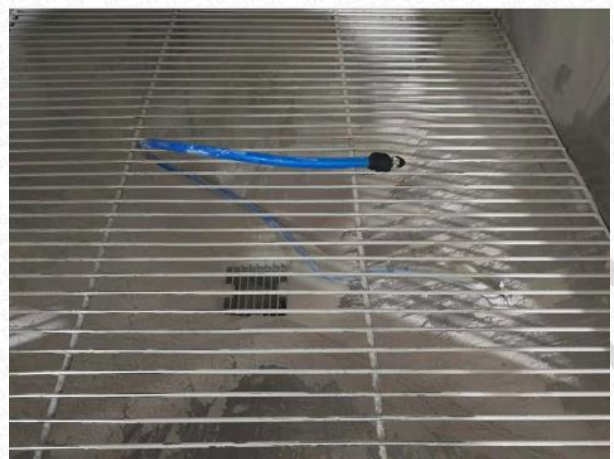
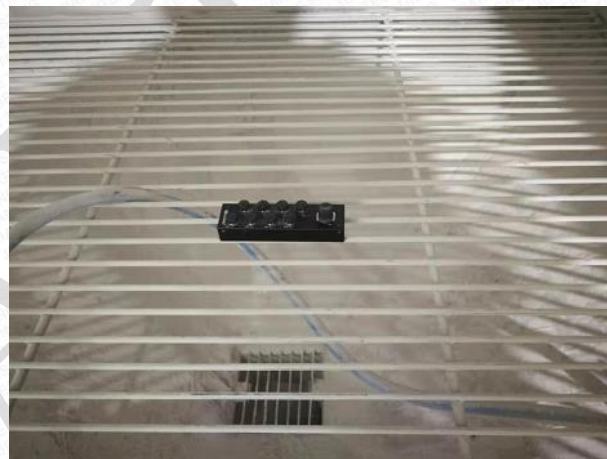
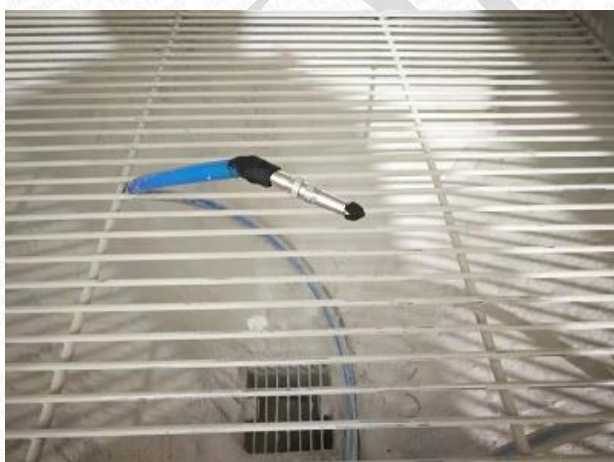
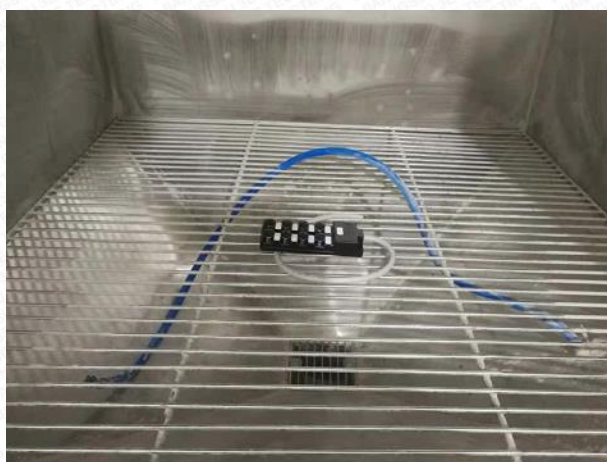
Fig.10 IP6X test(1#)

Fig.11 IP6X test (2#)

Fig.12 IP6X test(3#)

Fig.13 IP6X test(4#)

Fig.14 IP6X test(5#)

Fig.15 IP6X test(6#)

Fig.16 IP6X test(7#)

Fig.17 IP6X test(8#)

Fig.18 IP6X test(9#)

Test Item	Test Type	Test Conditions
IP6X	Tests for protection against access to hazardous parts	Push a 1.0 mm diameter wire specimen into any opening of the housing with 1N force
	Tests for protection against solid foreign objects	Place the sample in the dustproof box with talc powder dosage of 2 Kg/m ³ , Negative pressure is applied to the sample, and the exhaust speed is 50 times the shell

volume per hour. Test time: 2 h
--	--	------------------------------------

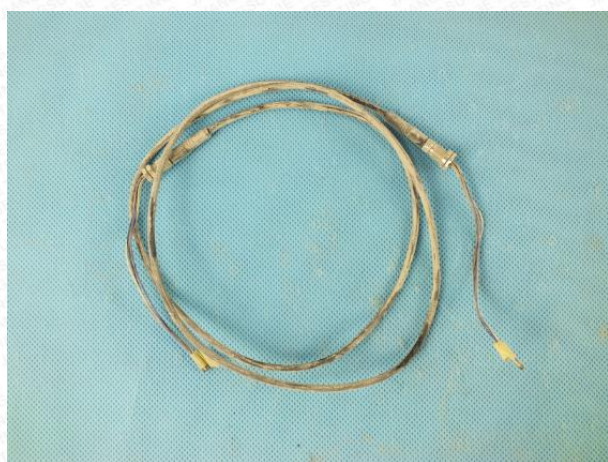
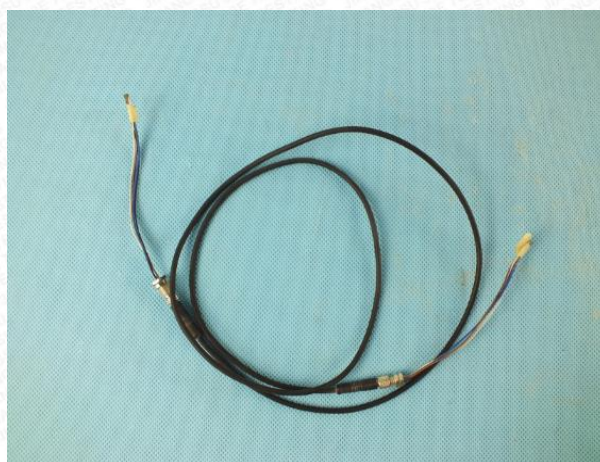
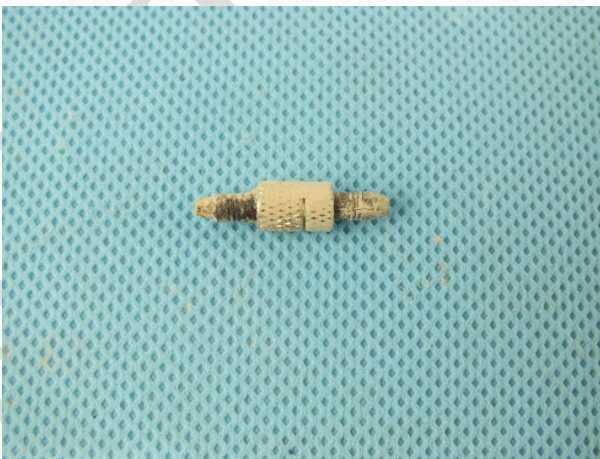
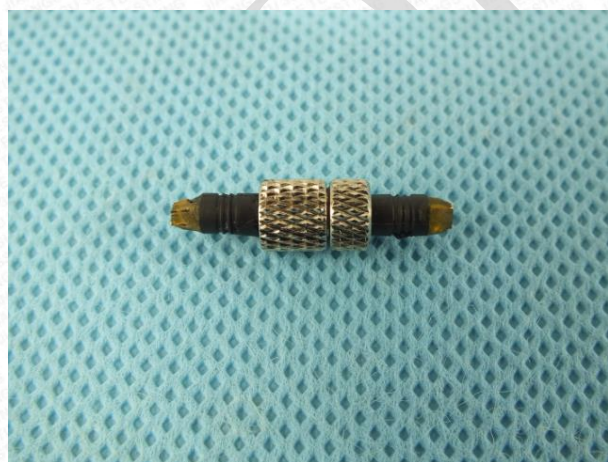
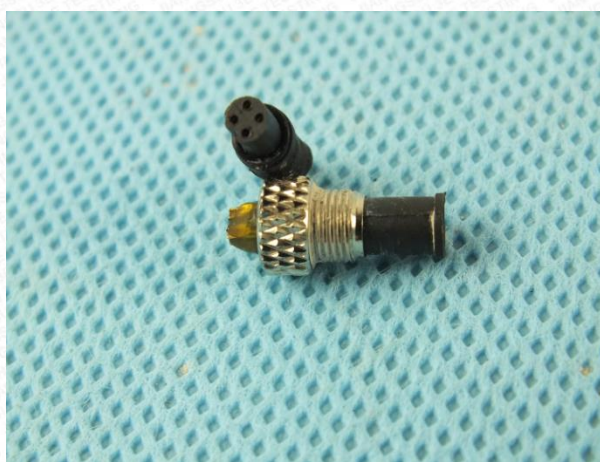
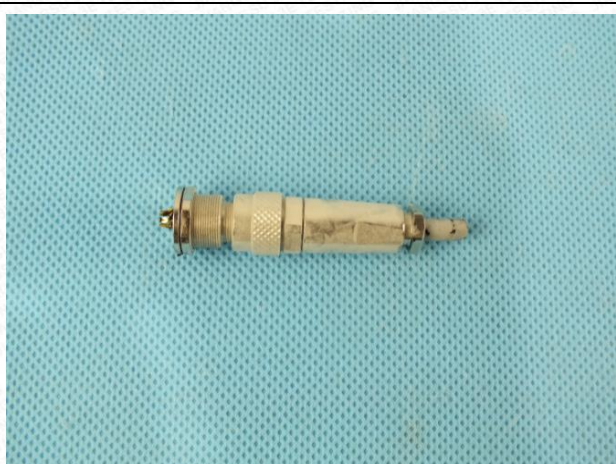
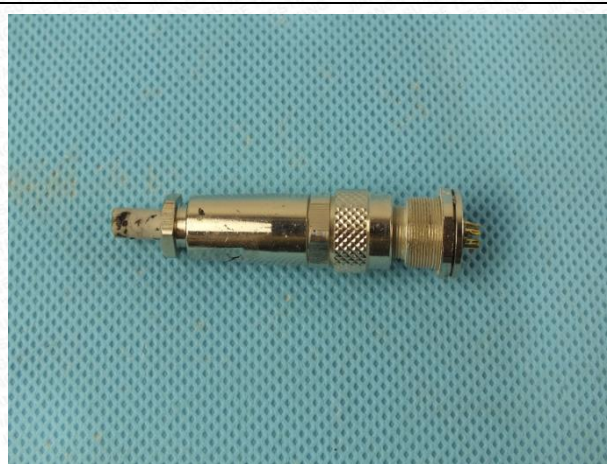
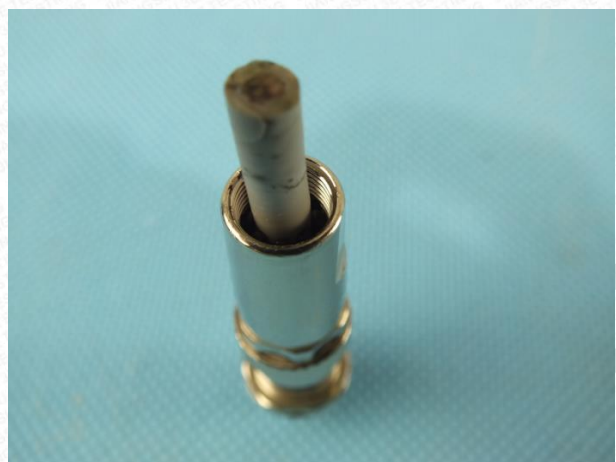
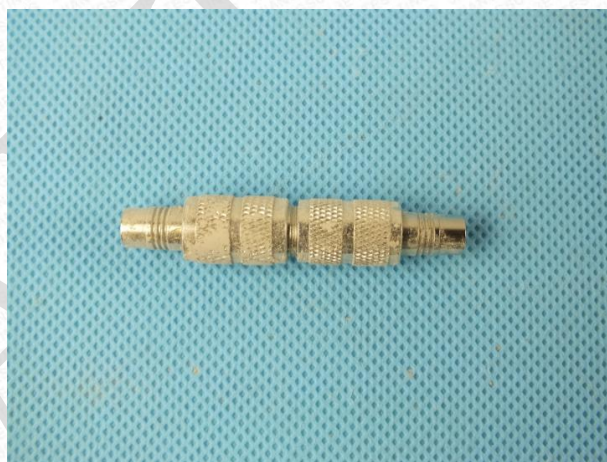
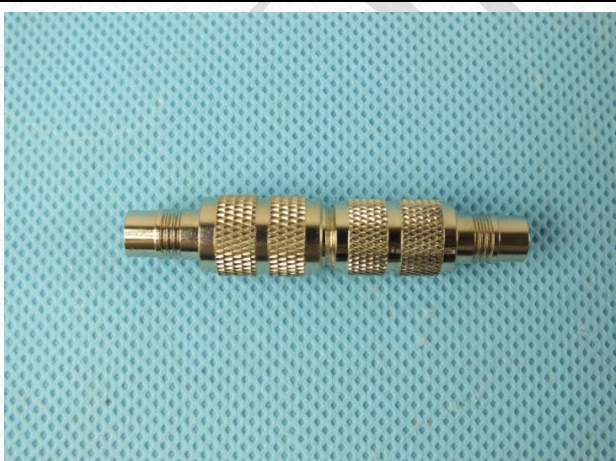
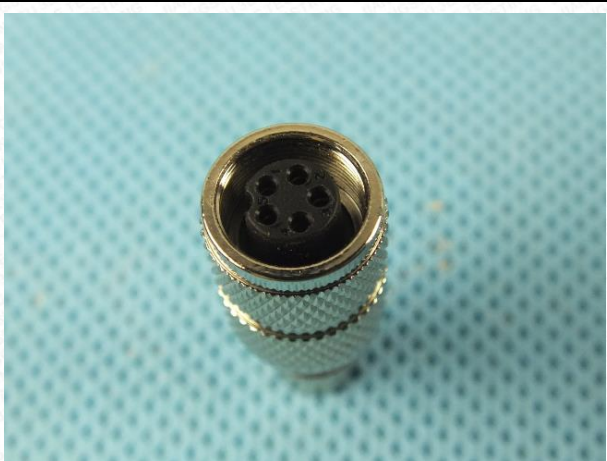
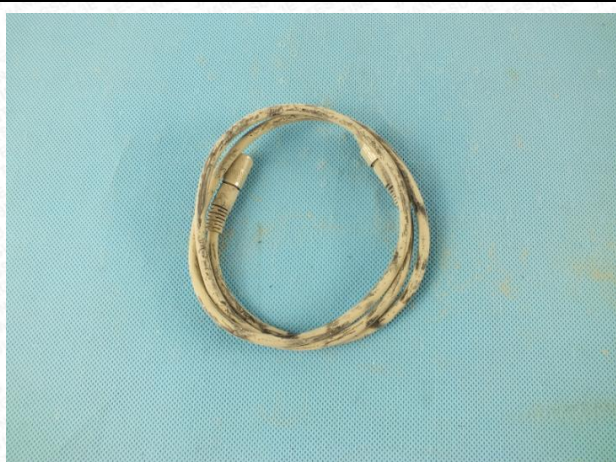
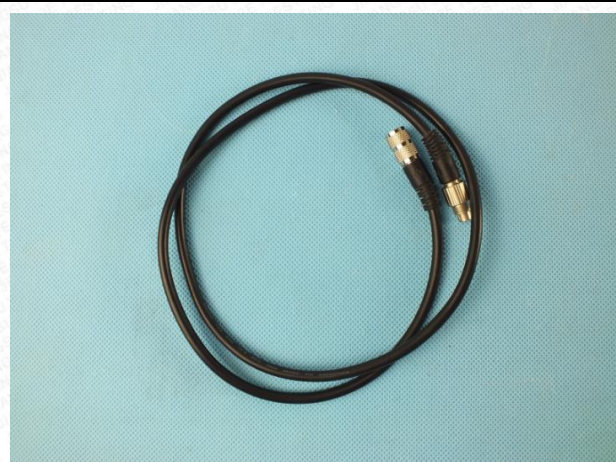
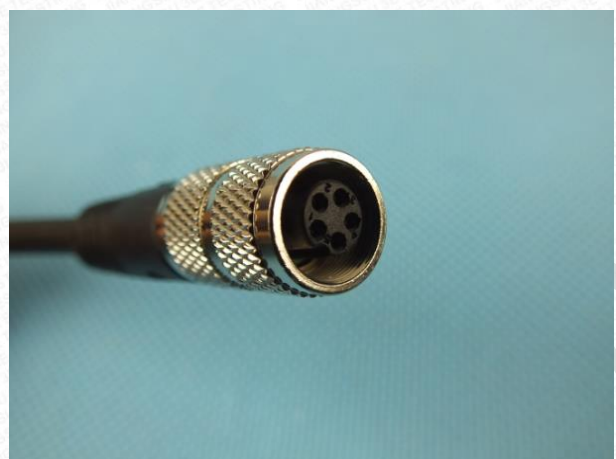
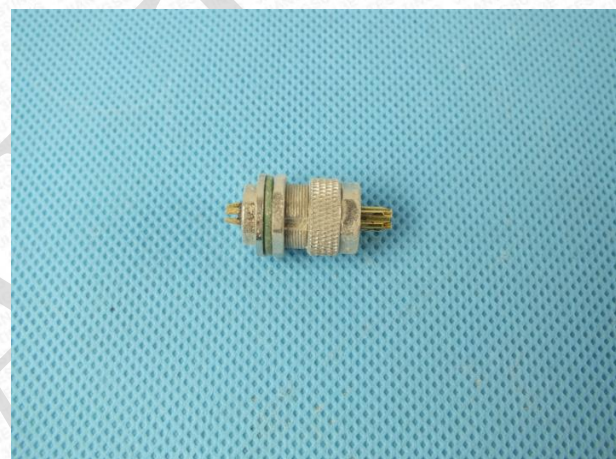
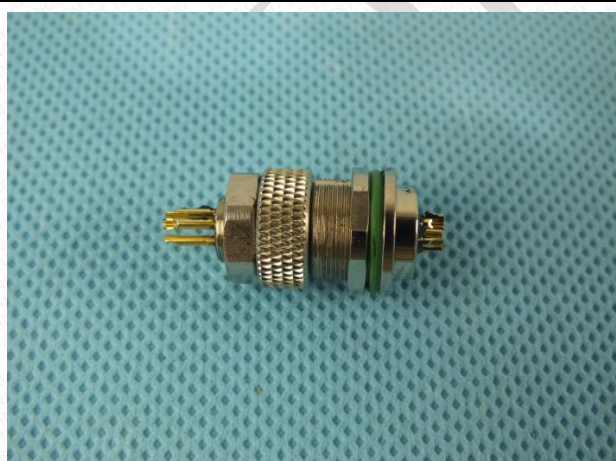
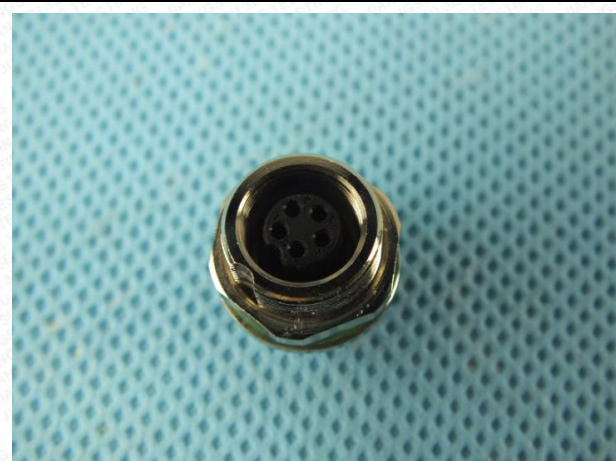
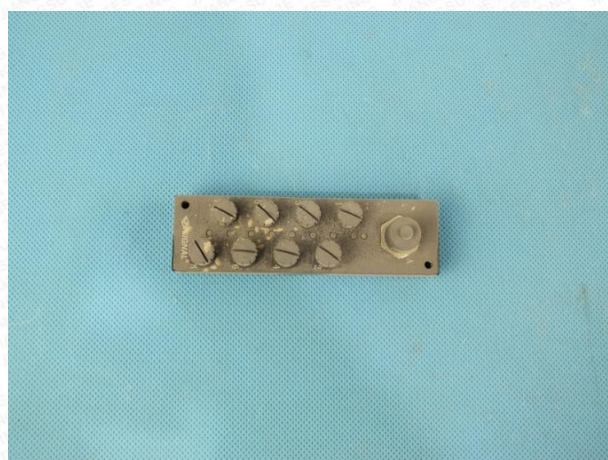
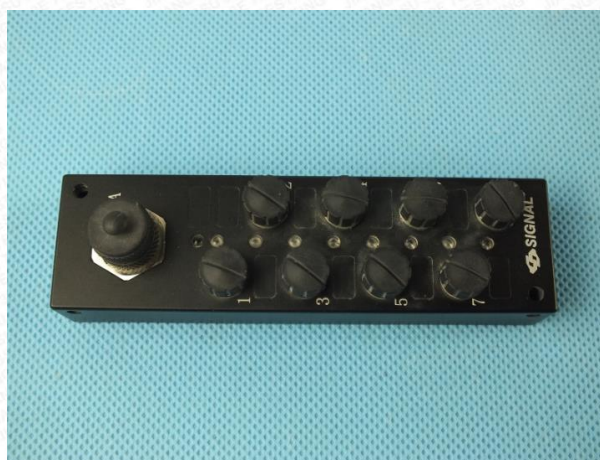
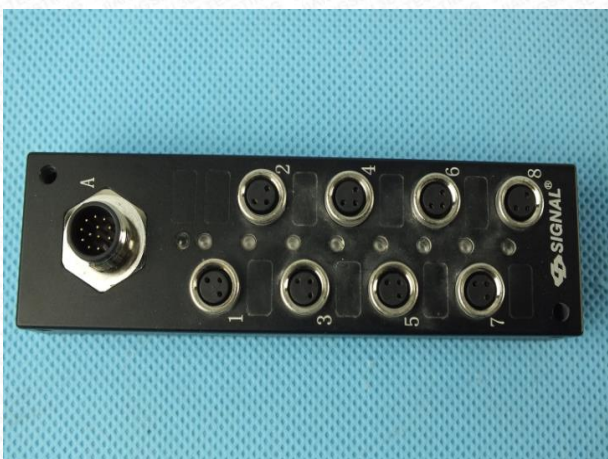
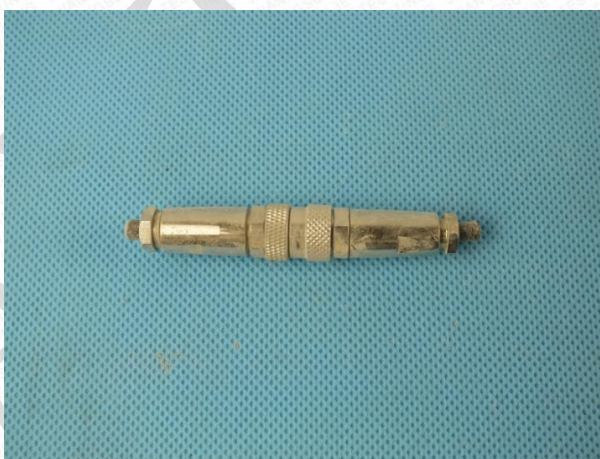
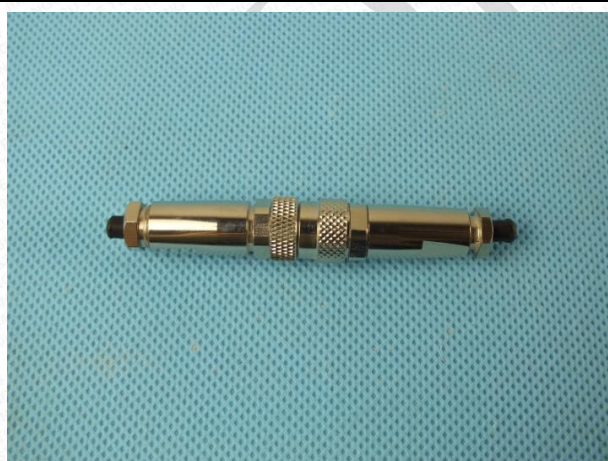
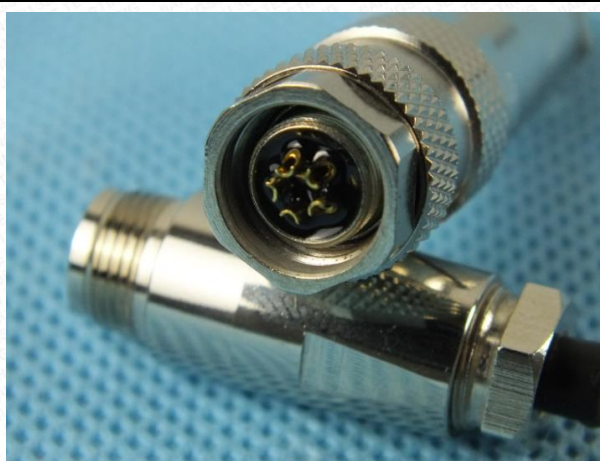
Fig.19 Sample photo after the test(1#)

Fig.20 Sample photo after the test(1#)

Fig.21 Sample photo after the test(1#)

Fig.22 Sample photo after the test(2#)

Fig.23 Sample photo after the test(2#)

Fig.24 Sample photo after the test(2#)

Fig.25 Sample photo after the test(3#)

Fig.26 Sample photo after the test(3#)

Fig.27 Sample photo after the test(3#)

Fig.28 Sample photo after the test(4#)

Fig.29 Sample photo after the test(4#)

Fig.30 Sample photo after the test(4#)

Fig.31 Sample photo after the test(5#)

Fig.32 Sample photo after the test(5#)

Fig.33 Sample photo after the test(5#)

Fig.34 Sample photo after the test(6#)

Fig.35 Sample photo after the test(6#)

Fig.36 Sample photo after the test(6#)

Fig.37 Sample photo after the test(7#)

Fig.38 Sample photo after the test(7#)

Fig.39 Sample photo after the test(7#)

Fig.40 Sample photo after the test(8#)

Fig.41 Sample photo after the test(8#)

Fig.42 Sample photo after the test(8#)

Fig.43 Sample photo after the test(9#)

Fig.44 Sample photo after the test(9#)

Fig.45 Sample photo after the test(9#)

Sample No.	Test Type	Test Result	Technical Requirement	Conclusion
E19072900401	Tests for protection against access to hazardous parts	Metal wire does not enter the shell	Adequate clearance is kept between the access probe and hazardous parts	Pass
	Tests for protection against solid foreign objects	No ingress of dust	No deposit of dust is observable	Pass
E19072900402	Tests for protection against access to hazardous parts	Metal wire does not enter the shell	Adequate clearance is kept between the access probe and hazardous parts	Pass
	Tests for protection against solid foreign objects	No ingress of dust	No deposit of dust is observable	Pass
E19072900403	Tests for protection against access to hazardous parts	Metal wire does not enter the shell	Adequate clearance is kept between the access probe and hazardous parts	Pass
	Tests for protection against solid foreign objects	No ingress of dust	No deposit of dust is observable	Pass

E19072900404	Tests for protection against access to hazardous parts	Metal wire does not enter the shell	Adequate clearance is kept between the access probe and hazardous parts	Pass
	Tests for protection against solid foreign objects	No ingress of dust	No deposit of dust is observable	Pass
E19072900405	Tests for protection against access to hazardous parts	Metal wire does not enter the shell	Adequate clearance is kept between the access probe and hazardous parts	Pass

Tests for protection against solid foreign objects	No ingress of dust	No deposit of dust is observable	Pass
E19072900406	Tests for protection against access to hazardous parts	Metal wire does not enter the shell	Adequate clearance is kept between the access probe and hazardous parts	Pass
	Tests for protection against solid foreign objects	No ingress of dust	No deposit of dust is observable	Pass
E19072900407	Tests for protection against access to hazardous parts	Metal wire does not enter the shell	Adequate clearance is kept between the access probe and hazardous parts	Pass
	Tests for protection against solid foreign objects	No ingress of dust	No deposit of dust is observable	Pass
E19072900408	Tests for protection against access to hazardous parts	Metal wire does not enter the shell	Adequate clearance is kept between the access probe and hazardous parts	Pass
	Tests for protection against solid foreign objects	No ingress of dust	No deposit of dust is observable	Pass

E19072900409	Tests for protection against access to hazardous parts	Metal wire does not enter the shell	Adequate clearance is kept between the access probe and hazardous parts	Pass
	Tests for protection against solid foreign objects	No ingress of dust	No deposit of dust is observable	Pass
